Northern Uganda Resilience Initiative (NURI) 2018-2022

**Quality Assessment of NURI Rural Infrastructure and Water Resource Management
Activities**

FINAL REPORT

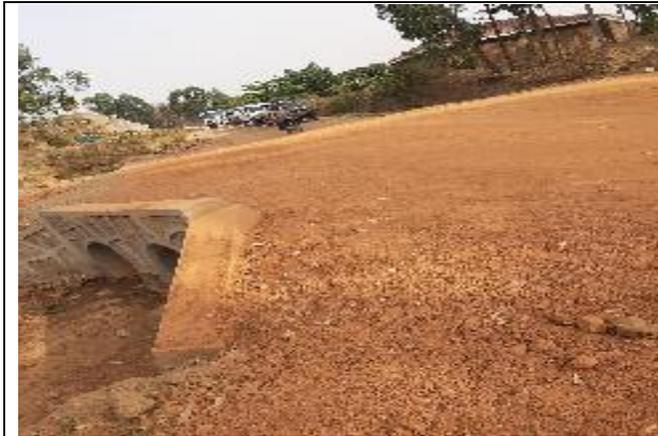
Figure 2: Culvert at Angucaku-st.Bakita-Oludri road

- 3) **Culvert Installation:** Some of the installed culverts are not well leveled and are humps which affecting the riding quality. Some are a safety hazard particularly to first time users of the road. In addition, the rate of erosion of the gravel will be higher and the culvert will be left bare and prone to being washed away. **Recommendation:** The approaches should attain the same level as the culvert.

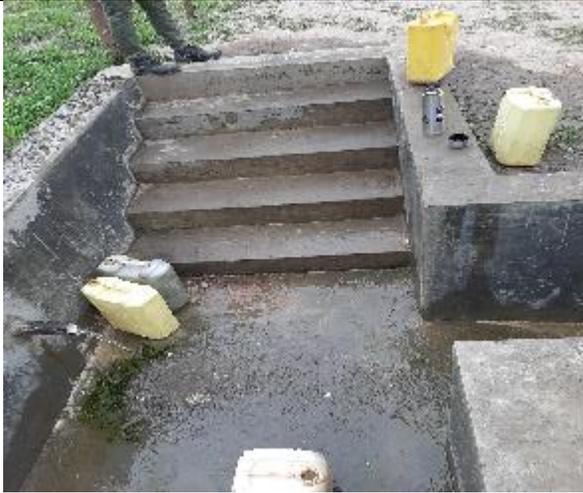
Figure 7: Spring protected at Goyiva

The springs were protected by sub-contractors engaged by DRC. The quality of masonry works including the retention wall and drains meet the specifications. However, some of the spring eyes were not well protected and as a result, water was seen oozing from the sides (Bapa and Goyiva springs). Some of the drains were short and had started developing cracks (Goyiva spring).

Some of the springs had small catchment area which do not conform to the sector standards. Goyiva springs for example has very small catchment area and farming activities were taking place upstream in distance of less than 50 meters. This may lead to pollution of the water and even drying up of the spring. Planting of trees or grass to protect the catchment had not been done. The WUC had not been trained on O&M.

Recommendation: Community provision of land for adequate catchment area protection should be a precondition for protecting the spring.

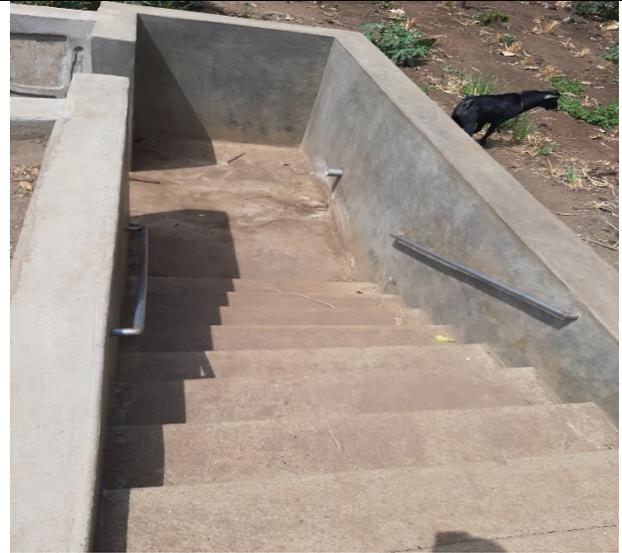
Figure 10: Seasonal spring at Bapa

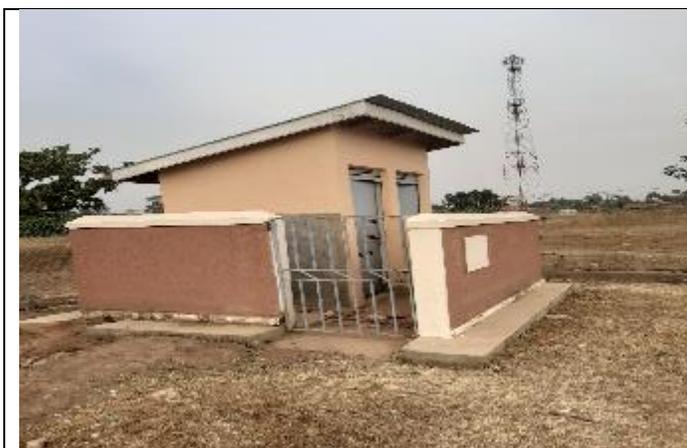
Figure 13: Toilet at Andelizu Market

Adequacy of sanitation facilities: The sanitation facilities did not meet minimum standards of having a urinal, washroom for women and adequate number of stances. There was a hand washing facility on one side of the toilet. There was not stance with facilities for physically disabled persons.

Recommendations: Construct sanitation facilities which meet minimum standards

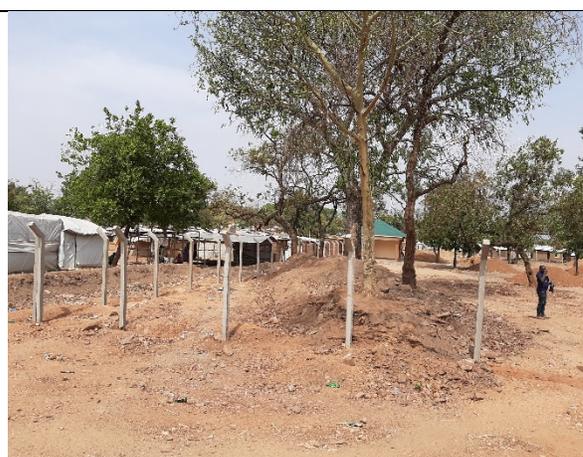
Figure 16: Fencing at Imvepi point J market

Quality of materials: There was no mechanism for testing the quality of materials to ensure they meet the requirements. The quality of sand was not meeting the specifications. Broken concrete poles were observed in Imvepi market and the gravel which was dumped could not meet the specifications

Recommendations: Materials should be inspected/tested and approved by qualified staff before use. Materials report should be on file.

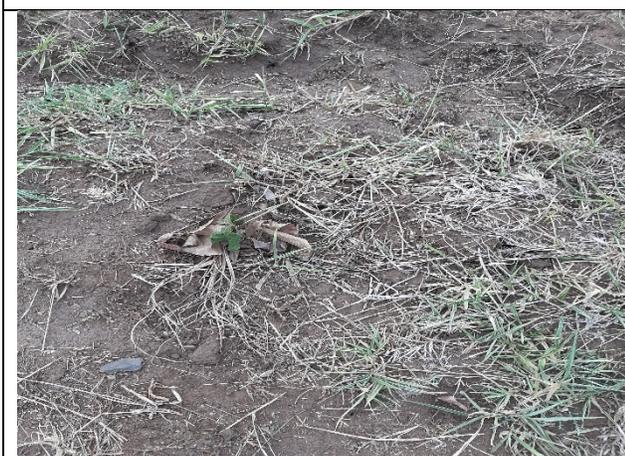
Figure 19: Adyee Food Forest -hit by drought

Low survival rate of tree raises the question whether right species were planted, soils tested or planting was done at the right time. In Kitgum where the survival rate is low, there is need to investigate the causes of low survival rate before replanting.

Recommendation: (i) There is need to investigate the causes of low survival rate of trees (ii) There is need for gap filling/ replanting to replace the seedlings that died.

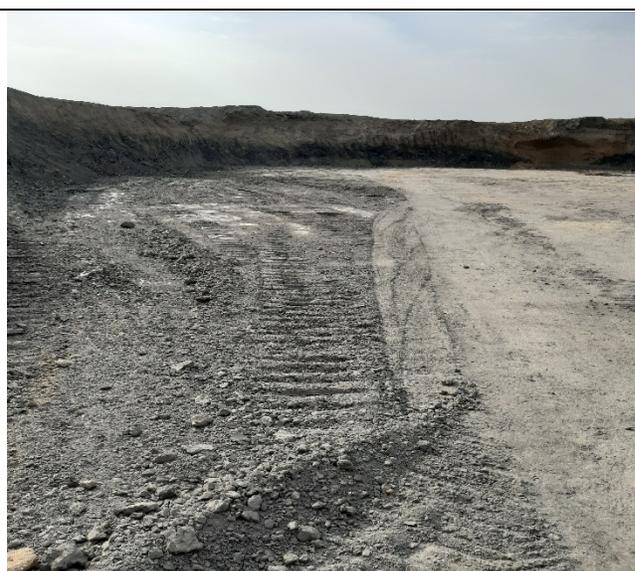
Figure 22: Valley dam under construction at Akinio

Lack of Project Bill Board: Building regulations require that such construction works should have a project sign post indicating the Client, Contractor, Supervising Engineer etc. This enable scrutiny and accountability.

Recommendation: NURI should consider hiring Independent Engineer to supervise and certify big complex works like Valley Tank to avoid possible litigation in case the dam gives way and there is loss of property and life.

Recommendation: Provide the project bill board/sign post as per the building regulations.
